# Newent Drainage Investigation Feasibility Report

Forest of Dean District Council

# Executive Summary

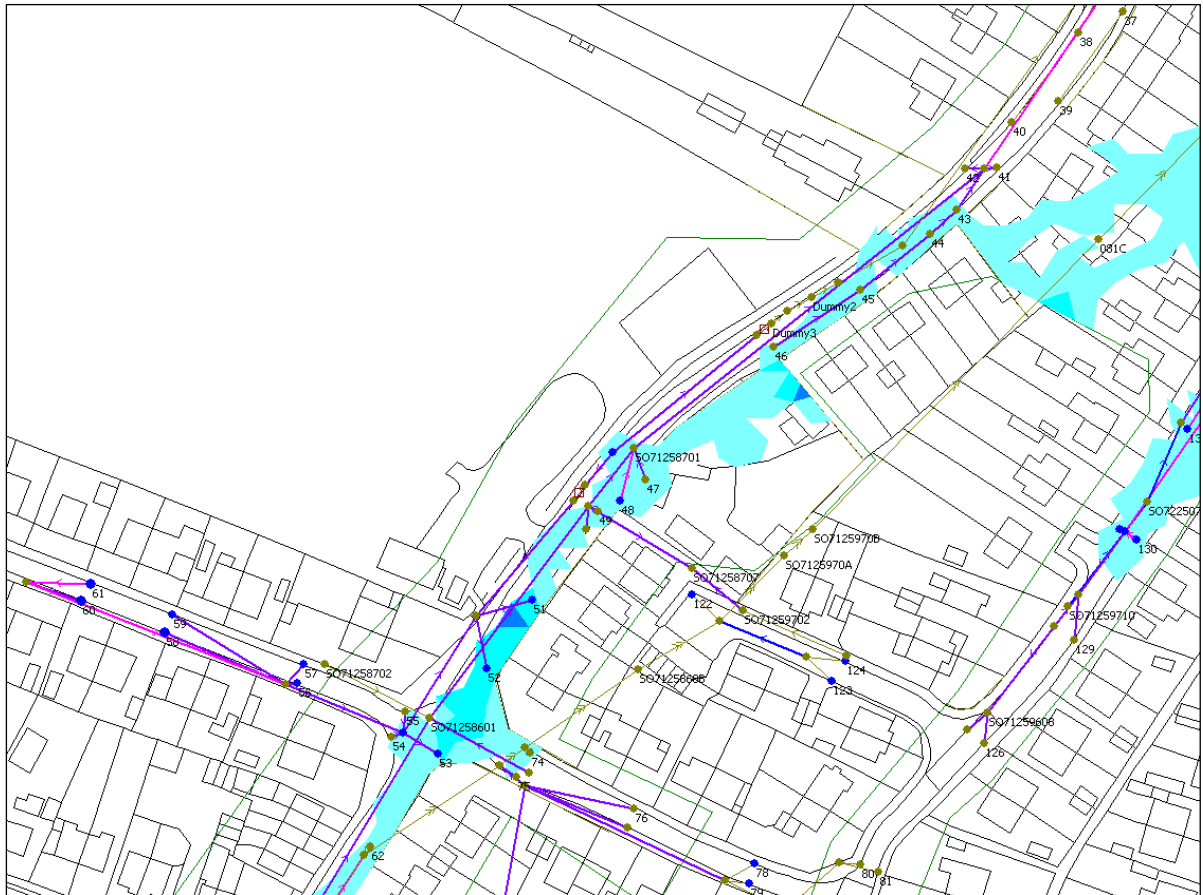
**Figure 14 – Watery Lane Predicted Flooding**

Figure 14 shows the extent of flooding along Watery Lane. The model predicted flooding differs slightly from that shown in Figure 8 (as identified by the local residents). The model does not predict flooding along Watery Lane after No. 16 (flows are not conveyed any further down Watery Lane to the north east). It is not possible to replicate the precise location and height of sand bag barriers laid down to protect the properties by the local residents.

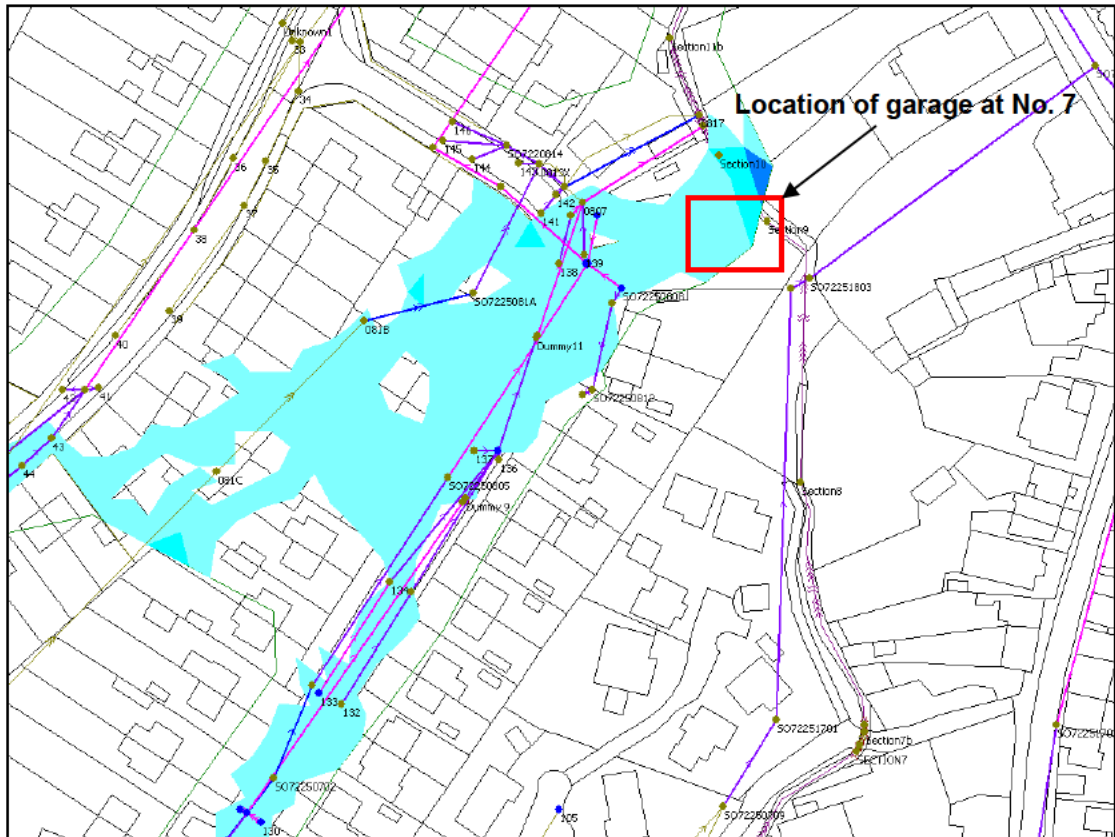
Figure 15 – Johnstone Road Predicted Flooding

Figure 15 shows the extent of the flooding along Johnstone Road. The model predicts out of sewer flooding from the surface water system at the south western extend of Johnstone Road which then flows in a north easterly direction down the road before pooling on the corner outside No.'s 5 and 7. The flood waters then flow round No. 7 Johnstone Road into Peacock Brook. The model may not be predicting the exact flood path correctly in this location as the garage/shed at No. 7 is known to divert the flows slightly differently.

The model predicted depths may vary from those observed on the corner of Johnstone Road as the extent and layout of sandbags laid down by local residents is not known which would significantly affect the depths in the model.

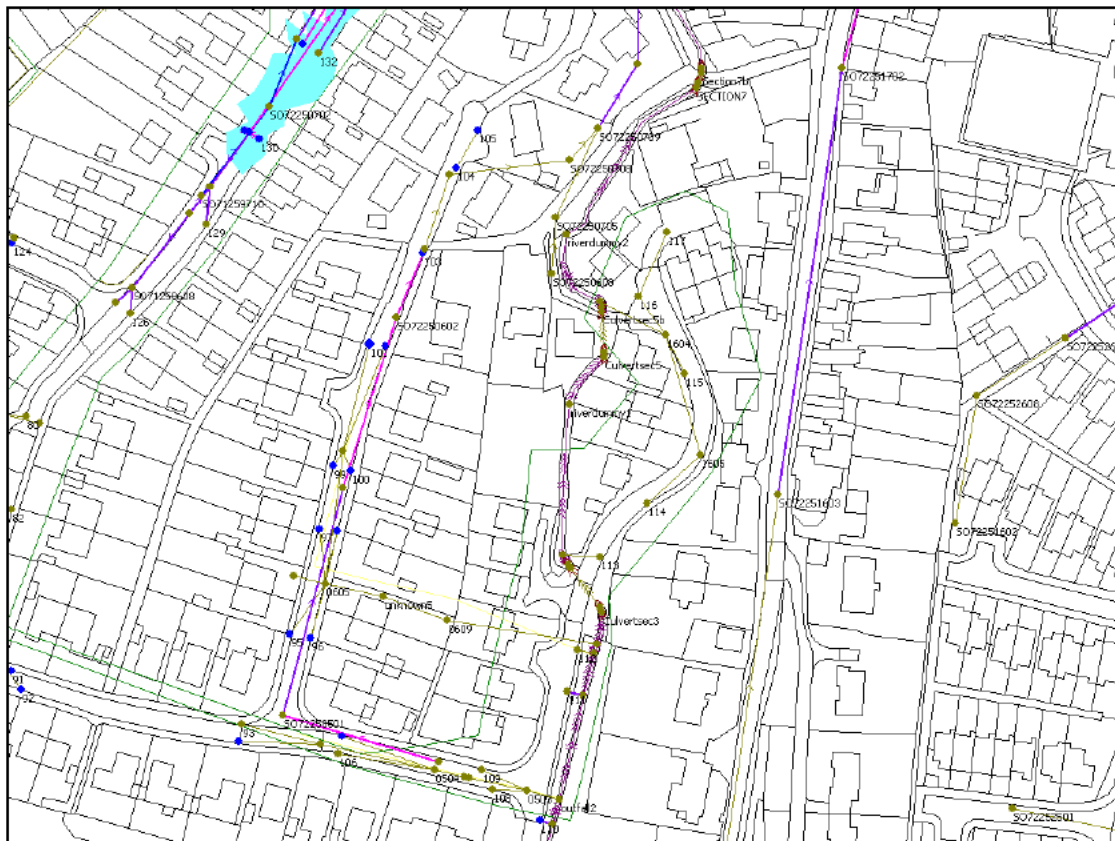
Figure 16 – Peacock Gardens Predicted Flooding

Figure 16 shows the extent of the model predicted flooding in the region of Peacock Gardens. It is clear that there is no flooding predicated from the surface water system in the area. The observed flooding in the area is likely to be from either insufficient number of highway gullies or poorly maintained existing road gullies. If this is the case neither would be identified as a source of flooding in the model. In addition to this there does not appear to be any flap valves on the outlets to Peacock Brook and as such the flow may back up the system thus reducing the capacity.

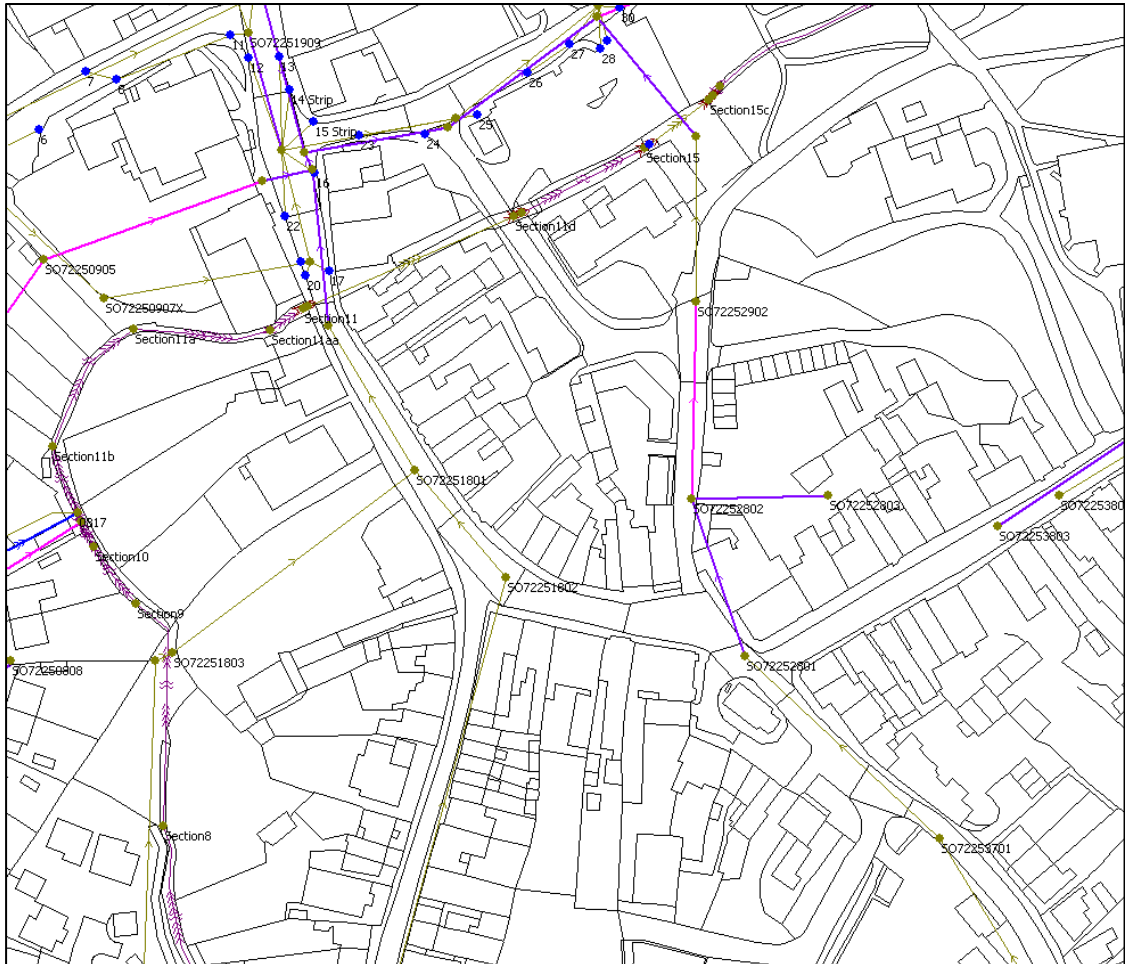
**Figure 17– Town Centre Predicted Flooding**

Figure 17 shows the town centre. No surface water flooding is predicted in the area. However, the observed flooding may be as a result of poorly maintained or insufficient number of gullies in the catchment, neither of which can be replicated in the model. The town centre is served by a combined sewerage system. These are no identified surface water sewers serving the town centre and the investigation of the combined system falls outside the brief of this study.
